Manhole Inspection Summary

Manhole # S09MM1039MH

Insp Date: **1/20/09 4:47 PM**

Location Address: **4901 DENMORE AVE**

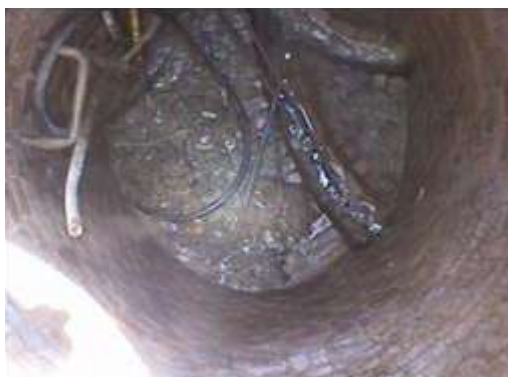
Defect 1

Count: **5** Missing: **0** ☒ **Corroded**

DEBRIS ON BENCH AND CORRODED STEPS

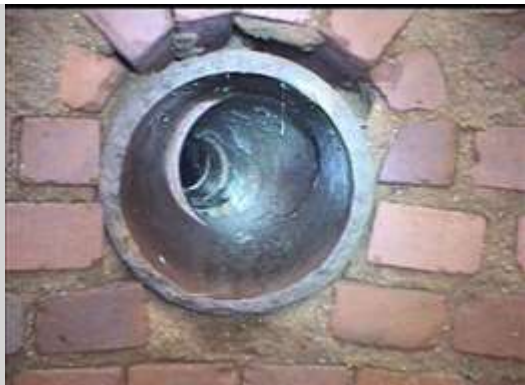
3 O'Clock Inflow

Pipe Height: (in.) Direct
Pipe Material: **Clay** ☐ Pipe Lined
Invert Depth: **5.84** (ft.) Flow Characteristics: **Slow**
Deposits: ☒ None ☐ Mud ☐ Sludge ☐ Debris ☐ Grease
Silt Depth: (in.) Deposits Extent:
Infiltration: **None** Pipe Seal Cond: **Broken**

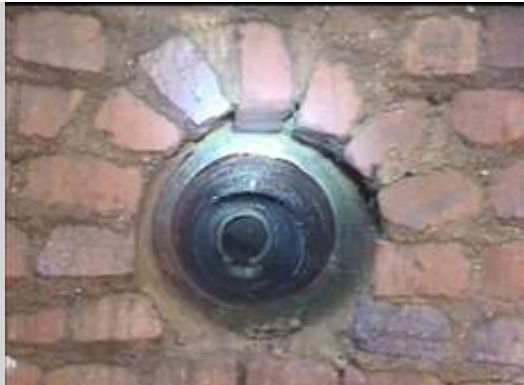
5 O'Clock Inflow

Infiltration: **None** Pipe Seal Cond: **Cracked**
